EXHIBIT 31

TO: LYFORD CAY PROPERTY OWNERS ASSOCIATION (POA)
FROM: KATHLEEN SULLIVAN SEALEY

RE: SITE VISIT TO SIMMS POINT ON MONDAY, 24 JANUARY 2010

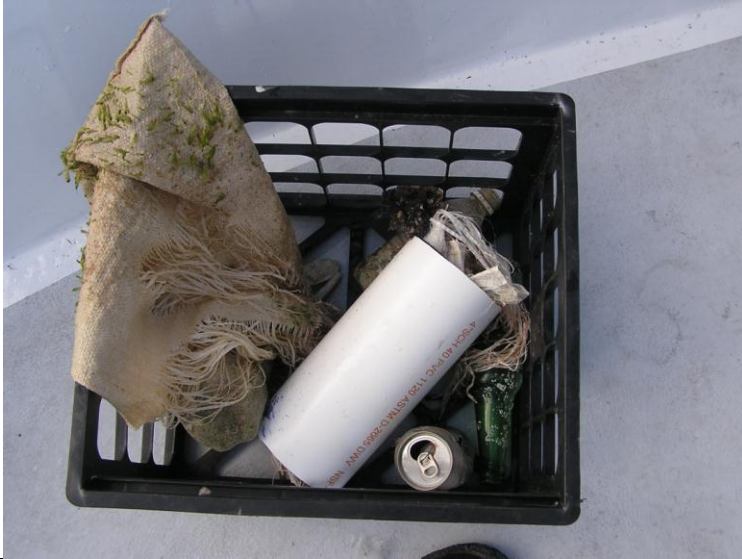
PHOTO 1:

The type of debris seen around Simms Point would appear to be associated with the sand bags (woven polypropylene) and placement of gabions for coastal stabilization

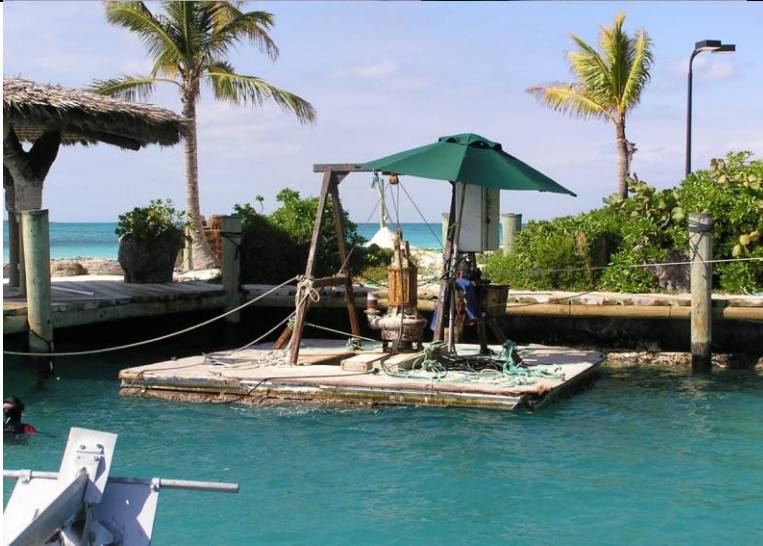
PHOTO 2:

The suction dredge is used to maintain access to the finger canal; however, there is evidence of extensive dredging adjacent to the Simms point property.

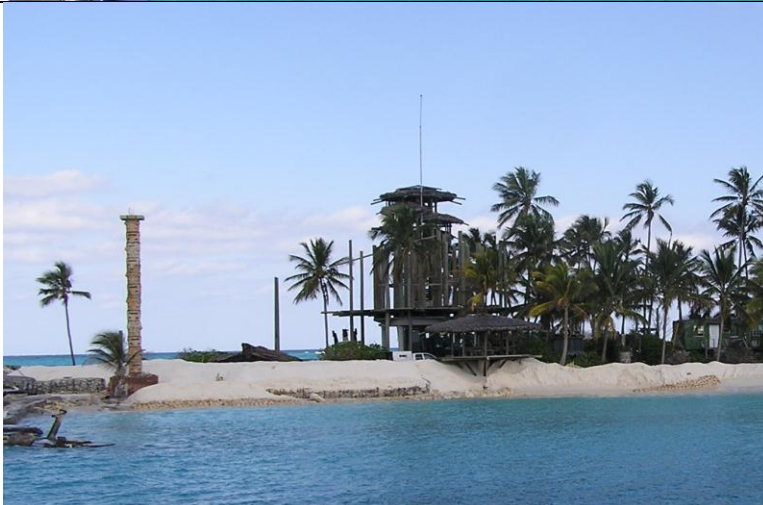
PHOTO 3:

Sand bags and gabions have been used to contain the large amounts of sand moved along the shoreline. Both sandbags and gabions are best applied along channels or rivers, and are not suitable for long-term marine coastal fortification.

Substantial amounts of debris from the sand bags and gabions have impacted the adjacent marine benthic habitats.

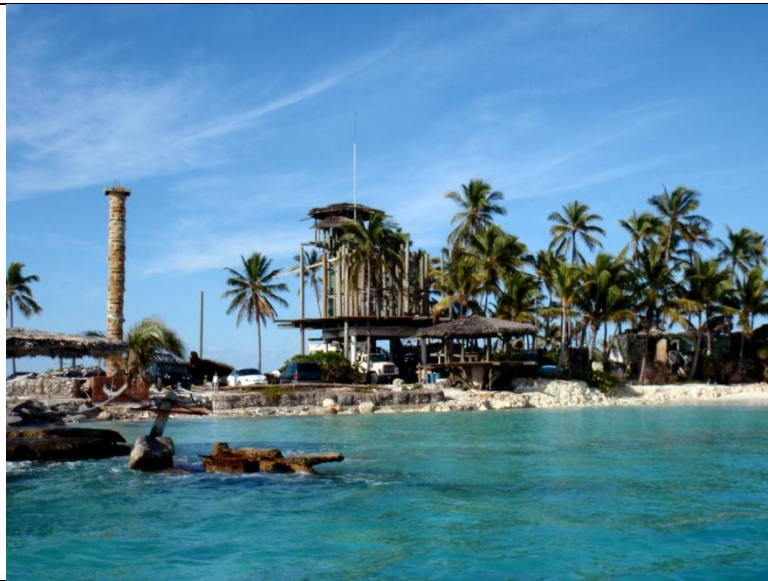
PHOTO 4:

Similar view from February 2010 illustrates the change over the past year with deposition of sand on Simms Point.

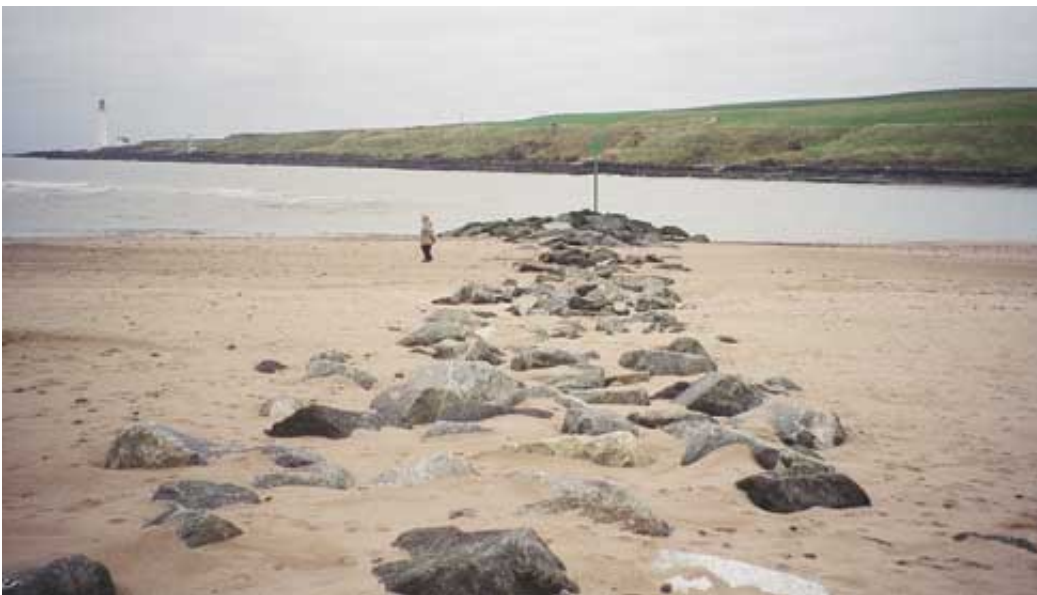
Recently built rock groyne at estuary mouth, constructed in association with beach renourishment of adjacent foreshore.
